# POST-CYCLONE RECOVERY PLAN FOR NI-VANUATU TOURISM BUSINESSES IN SHEFA PROVINCE

## STAGE 1 - EFATE, NGUNA & PELE ISLANDS

JUNE 2015

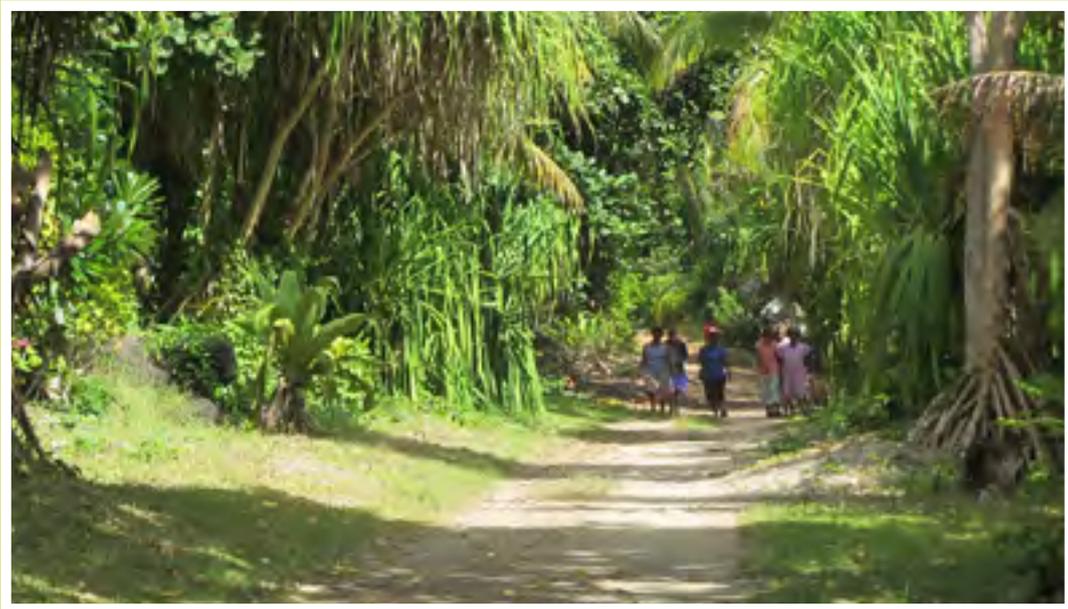
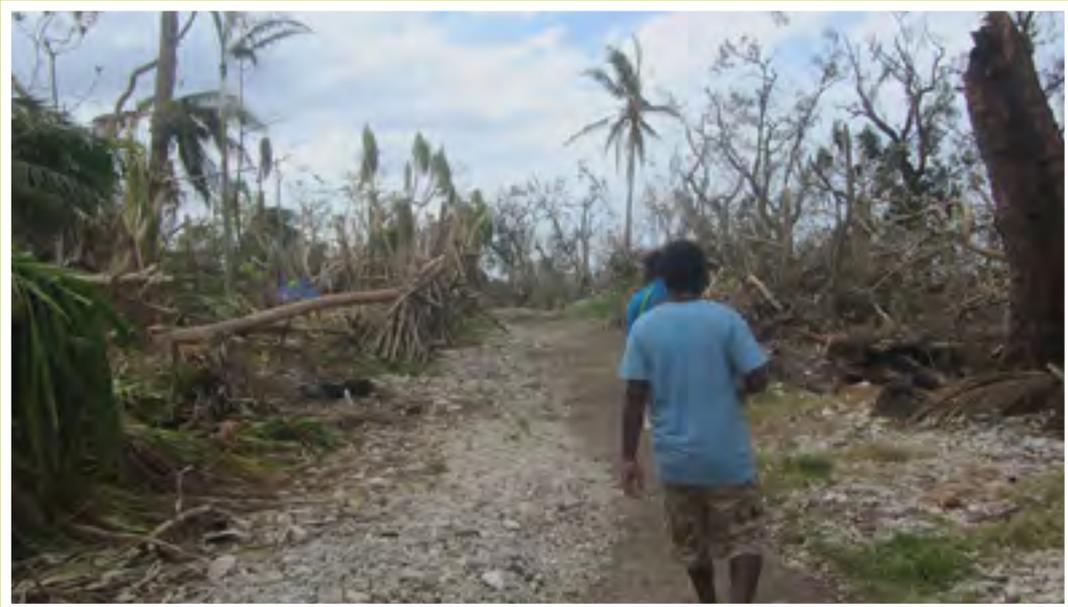
The road to Unakapu Village on Nguna, before and after Tropical Cyclone Pam

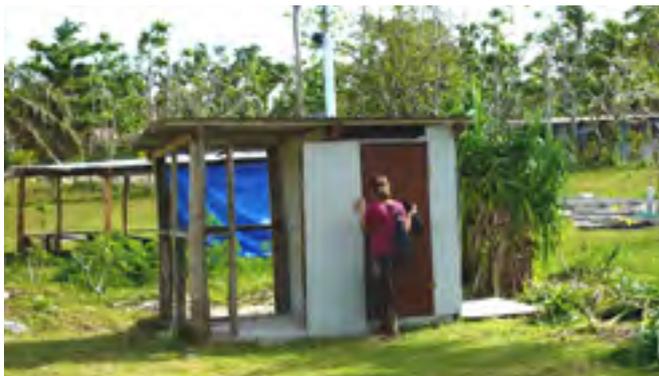
WASH engineer inspecting the toilet and shower at a bungalow on Pele

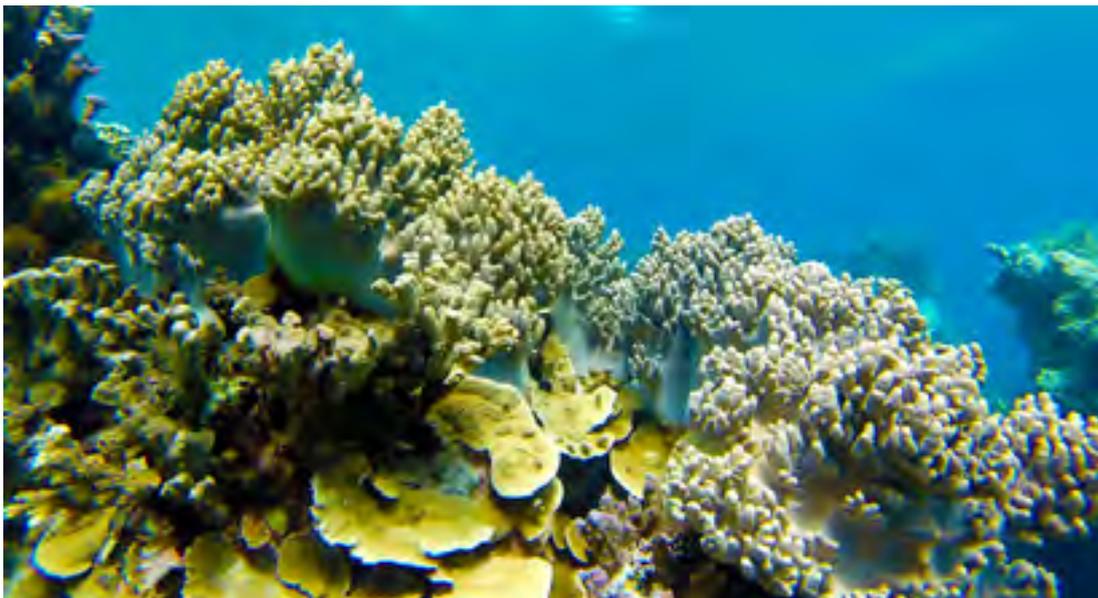
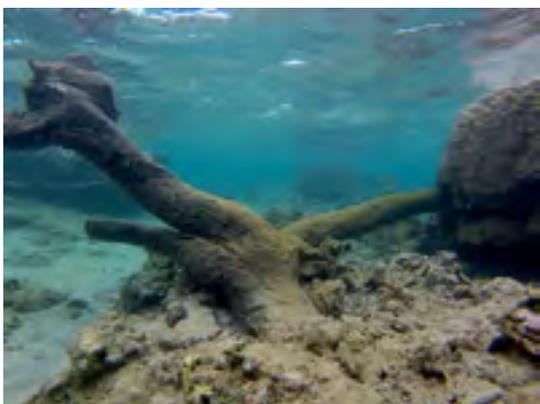
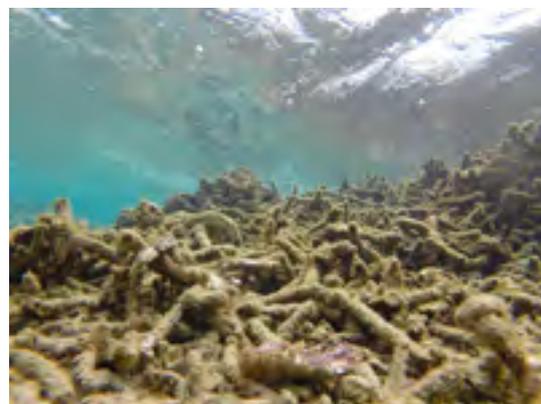
*Marine Conservation area in the vicinity of Uduna Cove Beach Bunglaows on Nguna. Top photo taken before Cyclone Pam, bottom two photos taken 18 May 2015. The amount of debris and coral rubble close to shore declines significantly at depth.*

- Permanently prohibit fishing in tourism sensitive sites.
- Re-evaluate the Community marine Conservation Area Management Plan.
- No walking on coral.
- Monitor for coral stressors (i.e. Crown of Thorns Starfish, coral bleaching, coral disease).
- Remove debris.
- Prohibit boat transit through tourism sensitive sites.
- Staff training in marine health and conservation.

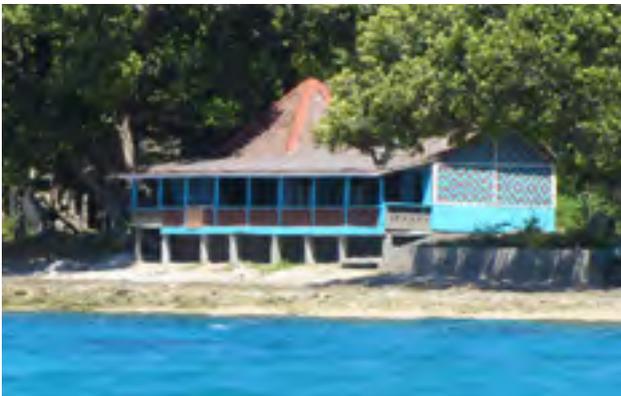
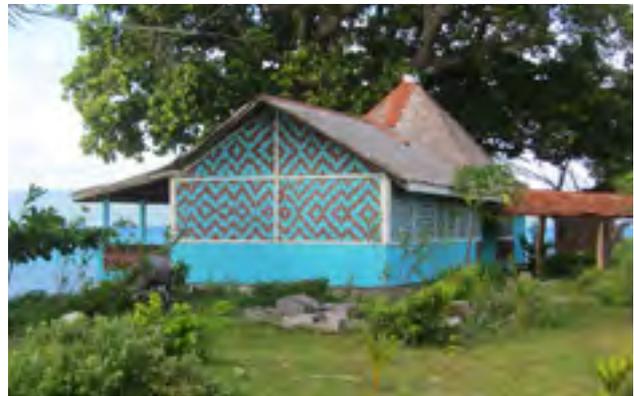
*Before Cyclone Pam*

- Island Breeze is a new bungalow that was due to open the week of the cyclone.
- The bungalow is built on the beach at the waters edge. Damage was caused by waves and sea surge rather than wind. Recommend that an expert assess the property before rebuilding in the same location.

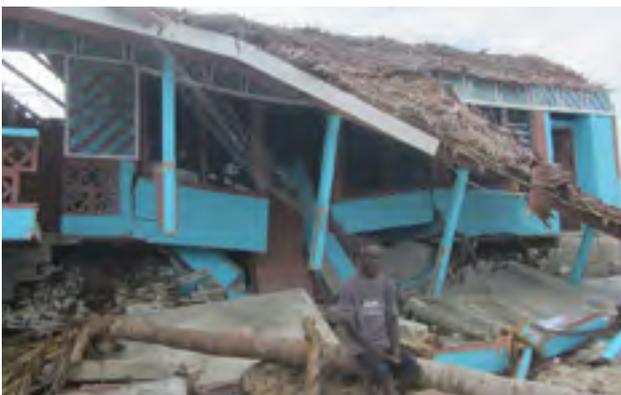
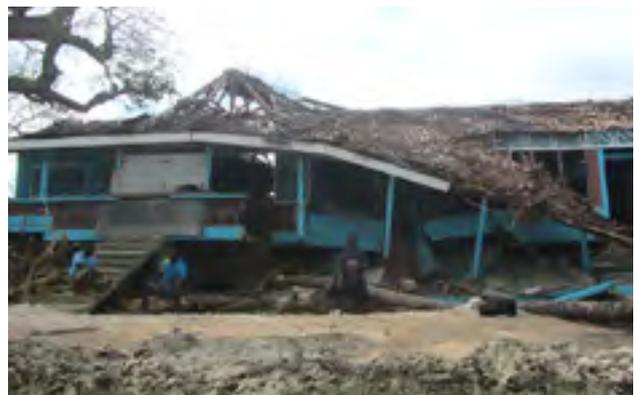
*24 March 2015*

Name: Island Breeze Bungalow  
Village: Taloa Village  
Owner: John Tamata  
Contact: 776 6084  
Assessed by: Ian Bani, Joseph Obed, Dianne Hambrook  
Date: 24/03/2015  
Damage: Extensive. Will need to be rebuilt  
Operational: No

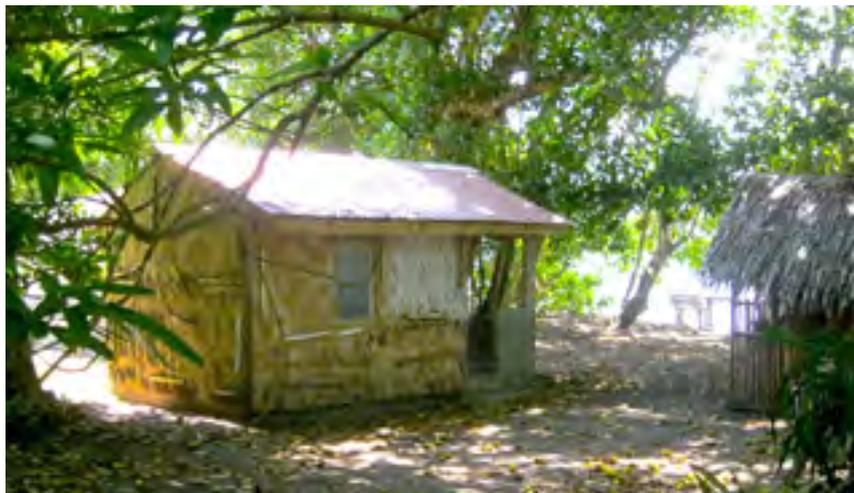
*Before Cyclone Pam*

- One bungalow was destroyed. The other was in the process of being built and can be salvaged.
- Owner wants to rebuild. No projected time-frame for this.
- Important to discuss requirements of Tourism Minimum Standards before building commences.

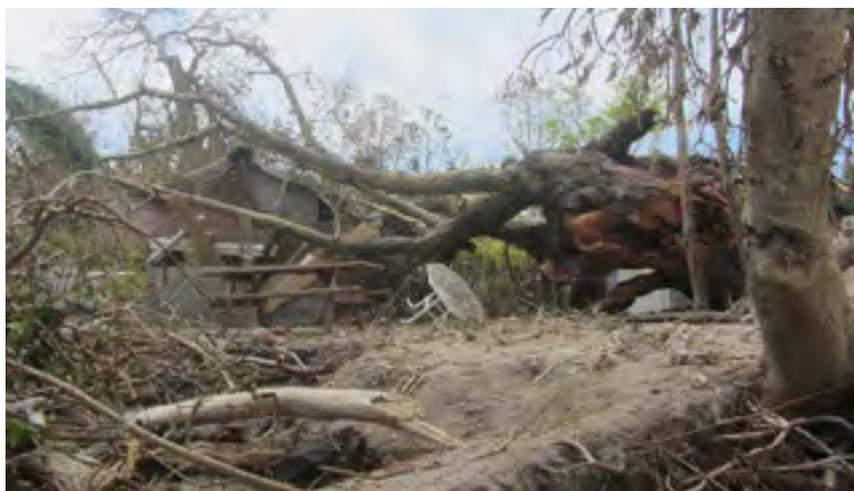
*24 March 2015*

Name: Mangamus Bungalow  
Village: Taloa Village  
Owners: Joel Kalfau  
Contact: 560 4312  
Assessed by: Dianne Hambrook  
Date: 08/04/2015  
Damage: Extensive. Will need to be rebuilt  
Operational: No

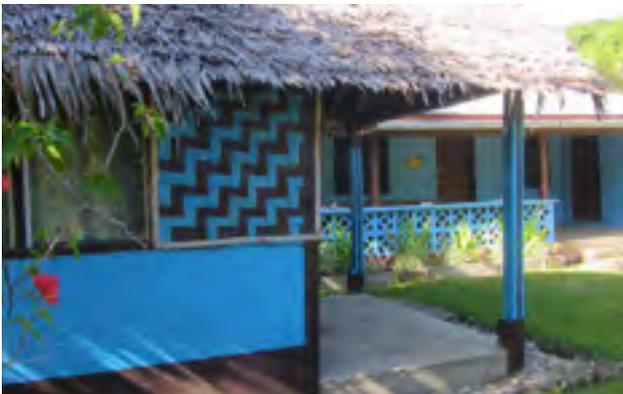
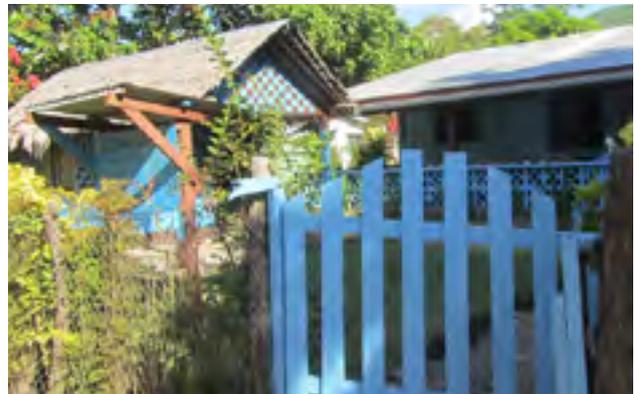
*Before Cyclone Pam*

- Is able to accommodate guests now but needs repairs. Expects to be operational in 2-3 months.
- Community project so may be eligible for donor funding for new water tank.

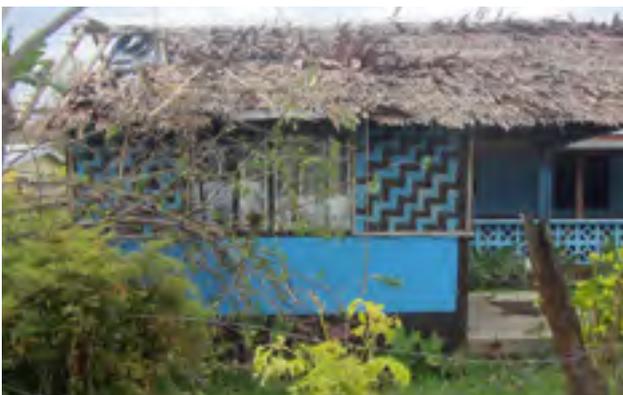
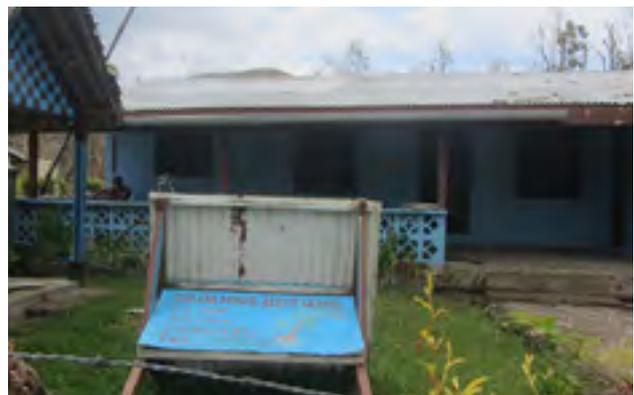
*24 March 2015*

Name: Nakie Womens Guesthouse  
Village: Taloa Village  
Owners: Taloa Village Nakie Womens Club (Leiwia Norman is President)  
Contact: 711 3375  
Assessed by: Ian Bani, Joseph Obed, Dianne Hambrook  
Date: 24/03/2015 and 09/04/2015  
Damage: Moderate  
Operational: No

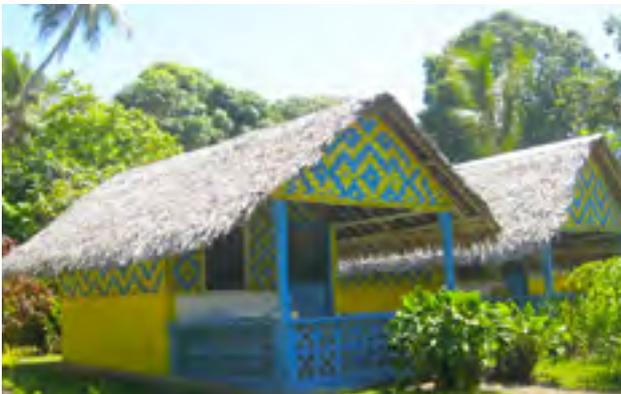
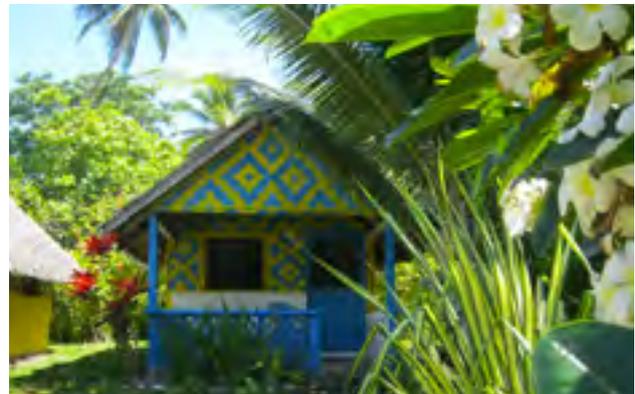
*Before Cyclone Pam*

- 3 of 5 bungalows operational. Roofing and solar lighting need repairs. Kitchen and dining area badly damaged. Mattresses have to be replaced.
- Expects to be able to accept guests within 1 to 2 months.
- Beach and gardens damaged.

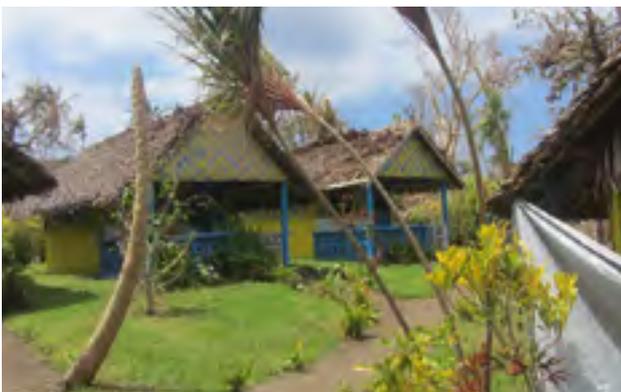
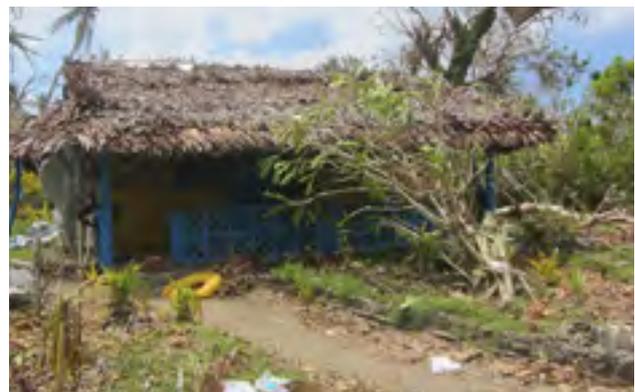
*24 March 2015*

Name: Uduna Cove Beach Bungalows  
Village: Taloa Village  
Owner: Emma Sisi  
Contact: 776 6263  
Assessed by: Ian Bani, Joseph Obed, Dianne Hambrook  
Date: 24/03/2015 and 08/04/2015  
Damage: Moderate  
Operational: No

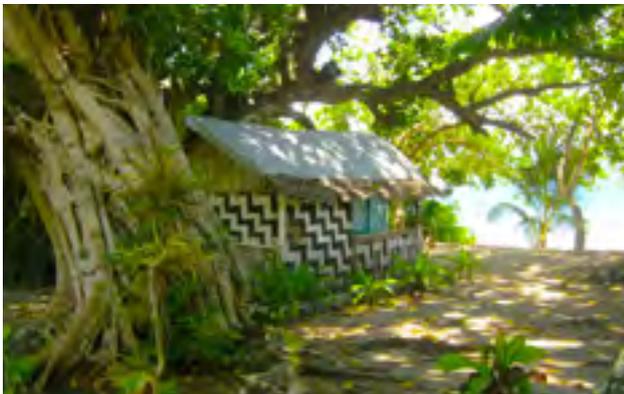
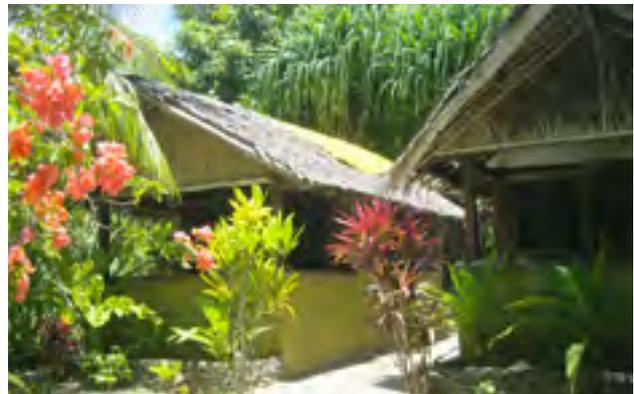
*Before Cyclone Pam*

- Needs to be completely rebuilt.
- Owner plans to build back better, in compliance with new tourism minimum standards.

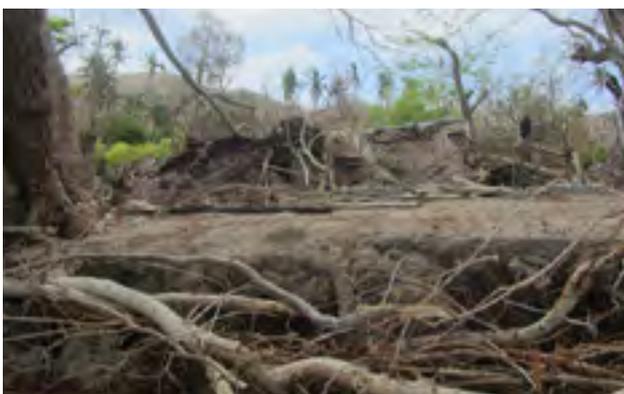
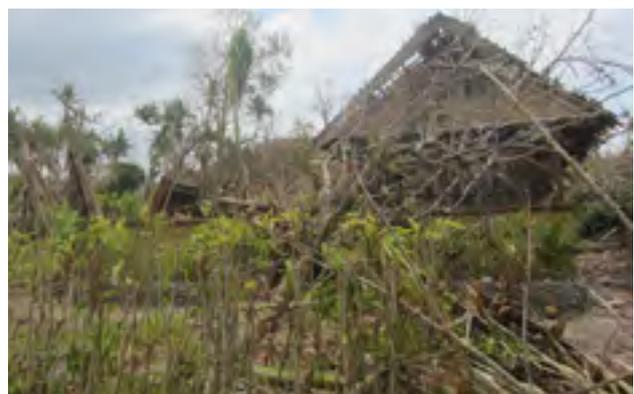
*24 March 2015*

Name: Vat-vaka Bungalows  
Village: Taloa Village  
Owner: Yohan Joseph  
Contact: 777 1916  
Assessed by: Dianne Hambrook  
Date: 08/04/2015  
Damage: Extensive  
Operational: No

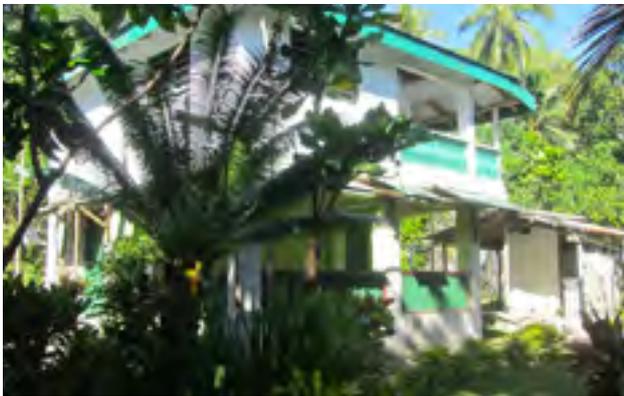
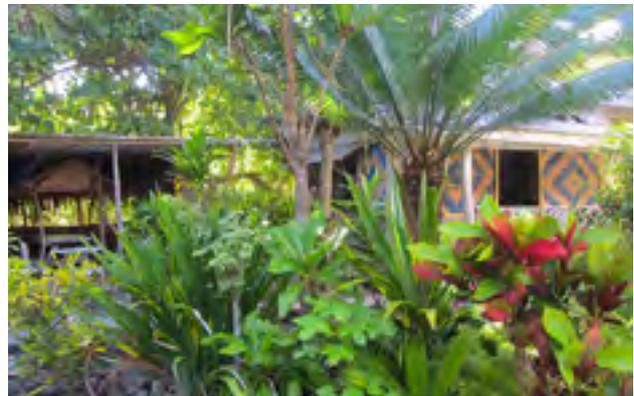
*Before Cyclone Pam*

- Needs some repairs.
- Water supply contaminated.
- Garden and surrounding bush significantly damaged.

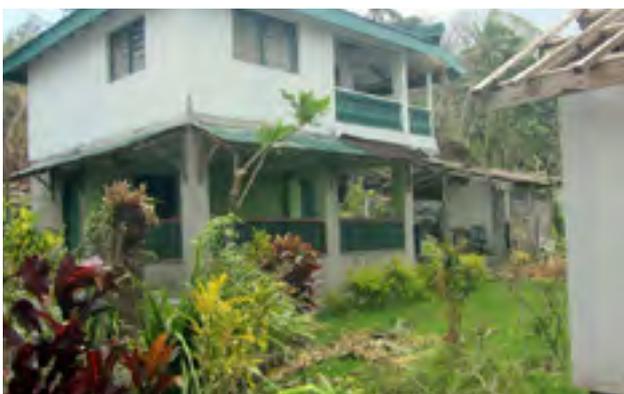
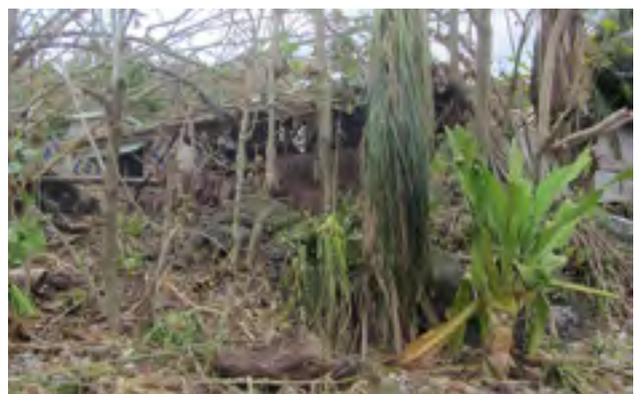
*24 March 2015*

Name: Paunvina Guesthouse  
Village: Unakapu Village  
Owner: Taris Tatangis  
Contact: 711 6821 (Eddie Kalo)  
Assessed by: Ian Bani, Joseph Obed, Dianne Hambrook  
Date: 24/03/2015  
Damage: Minor  
Operational: No

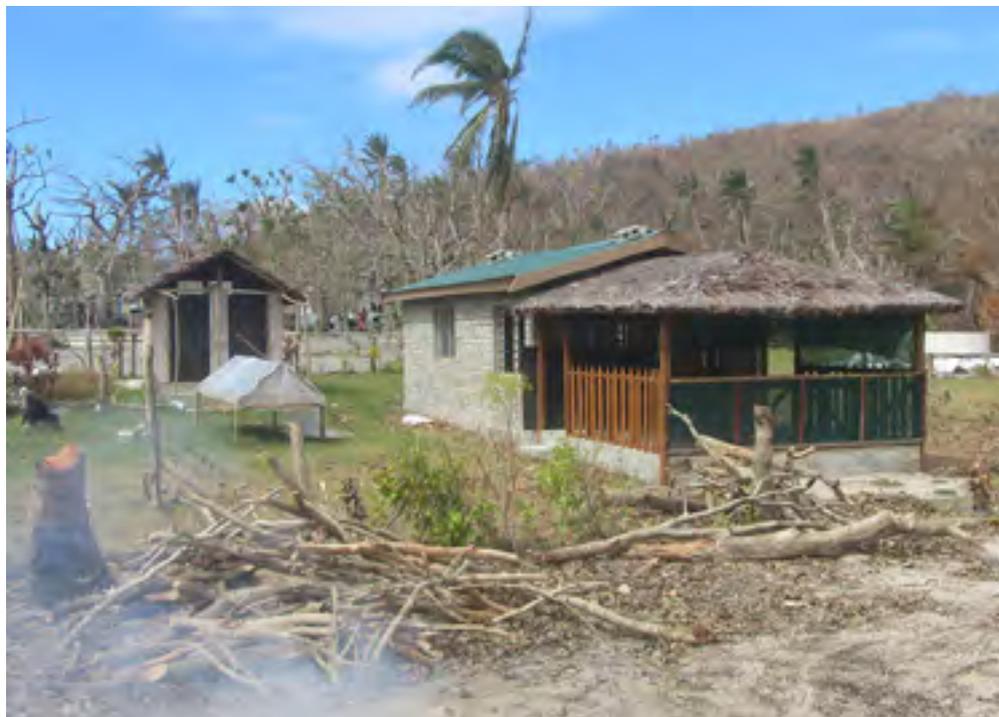
25 March 2015

Name: JJ Bungalow  
Village: Worearu Village  
Owners: John Jameson, Margaret Kalo (wife)  
Contact: 772 6476  
Assessed by: Kathy Garoleo, Dianne Hambrook  
Date: 25/03/2015  
Damage: Minimal  
Operational: No

- New bungalow only very recently completed (no pre-cyclone photo).
- Solar damaged, minor general repairs.
- Owner in New Zealand working on the RSE scheme in New Zealand, his wife will wait for him to return before making repairs.
- Expects to be operational in June 2015.

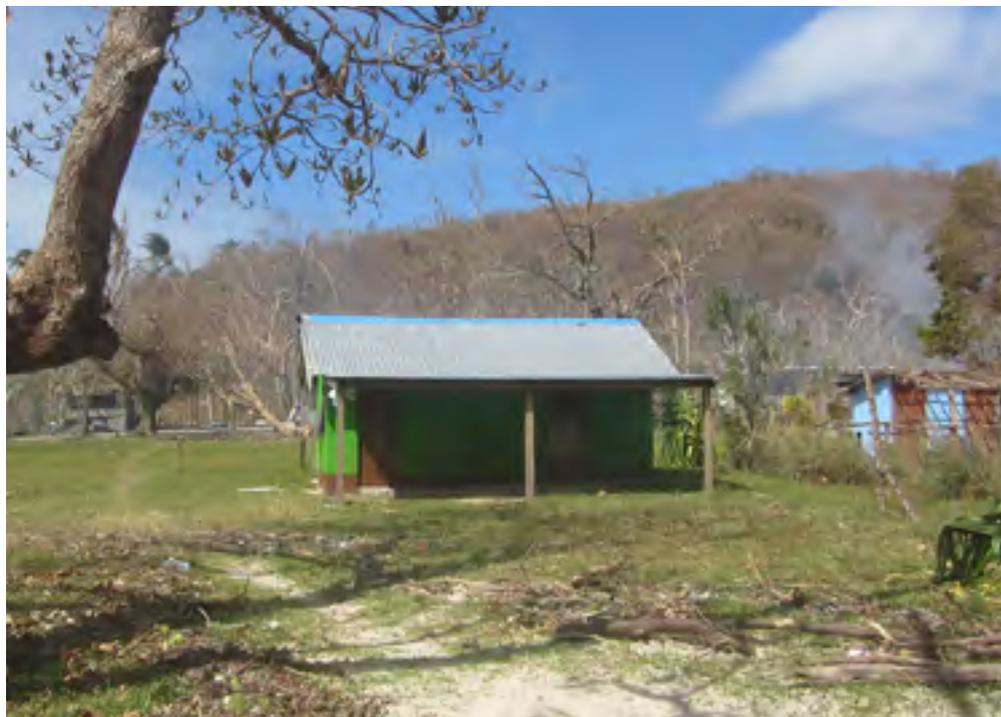
25 March 2015

Name: Jowi Beach Bungalow  
Village: Worearu Village  
Owner: David Samuel  
Contact: 562 2221 | 590 9491  
Assessed by: Kathy Garoleo, Dianne Hambrook  
Date: 25/03/2015  
Damage: Minimal  
Operational: No

- New bungalow only very recently completed (no pre-cyclone photo).
- Bathroom and toilet need repairs.
- General tidying of the grounds.
- Expects to be operational in June 2015.

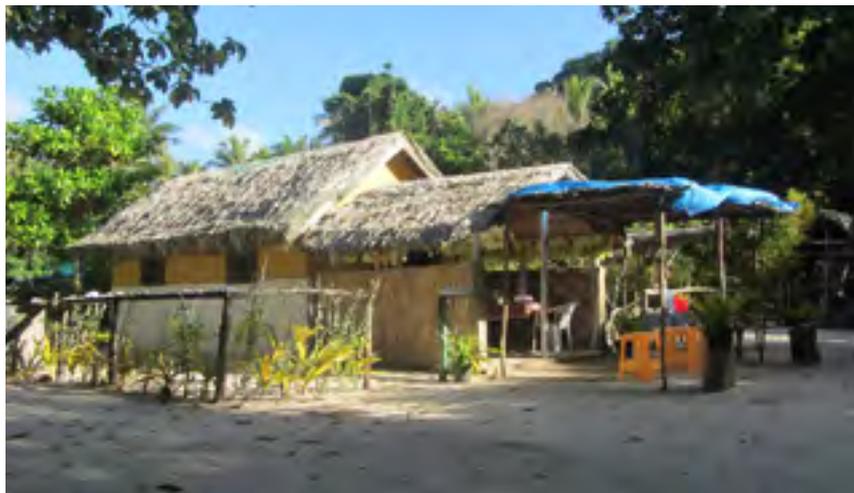
*Before Cyclone Pam*

- Roof needs repairs and veranda rebuilt.
- Rain water contaminated, solar damaged.
- Surrounding bush and gardens destroyed. No shade.
- Expects to be operational by June 2015.

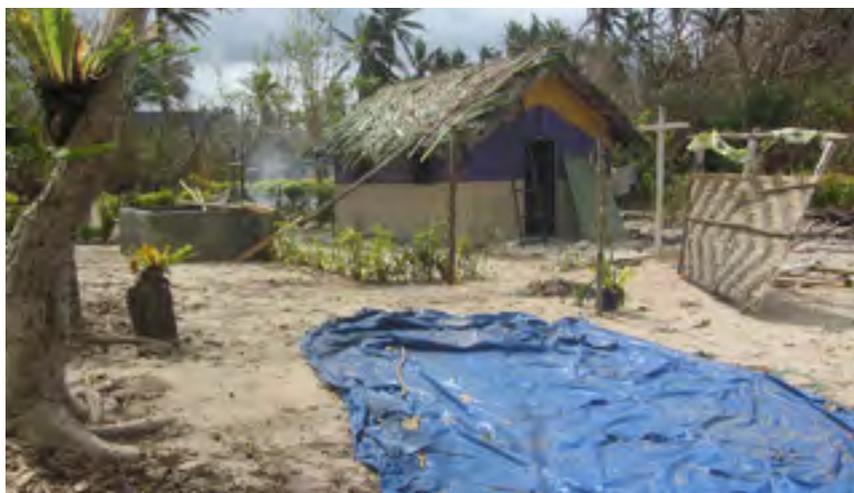
*25 March 2015*

Name: Sena Pa-Pa Bungalow  
Village: Worearu Village  
Owners: Frank and Aileen Kalkaua  
Contact: 542 4728  
Assessed by: Joseph Obed / Dianne Hambrook  
Date: 25/03/2015  
Damage: Significant  
Operational: No

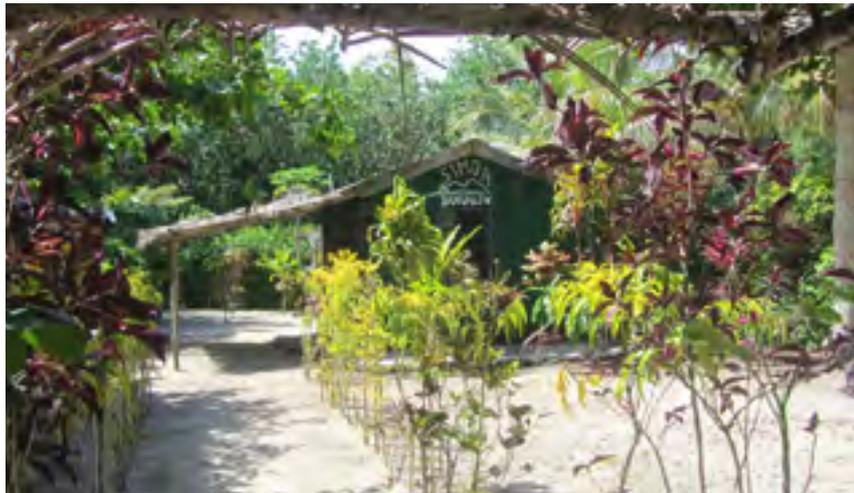
*Before Cyclone Pam*

- Roof of bathroom and toilet destroyed.
- 2 new cement bungalows currently being built. Have no roof or fixtures and didn't suffer any damage.

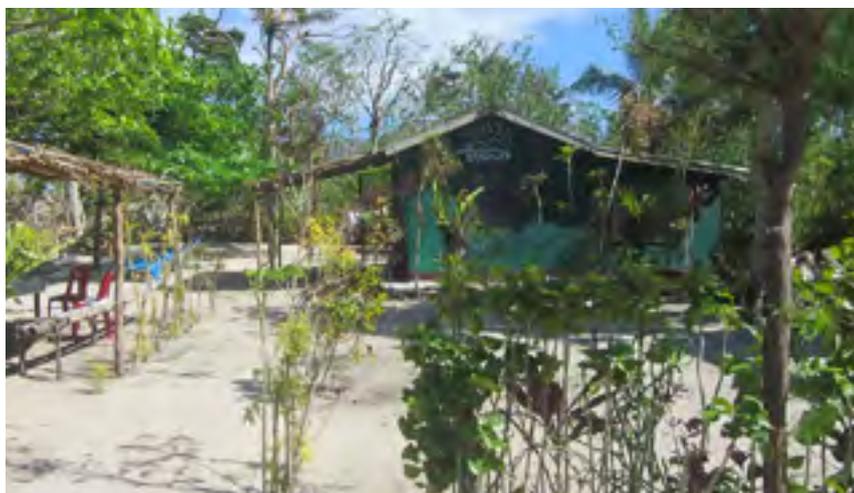
*09 April 2015*

Name: Simoa Bungalow  
Village: Worearu Village  
Owners: Mark and Miriam Song  
Contact: 568 6685  
Assessed by: Kathy Garoleo / Ian Bani  
Date: 25/03/2015  
Damage: Minor  
Operational: Yes, as of April

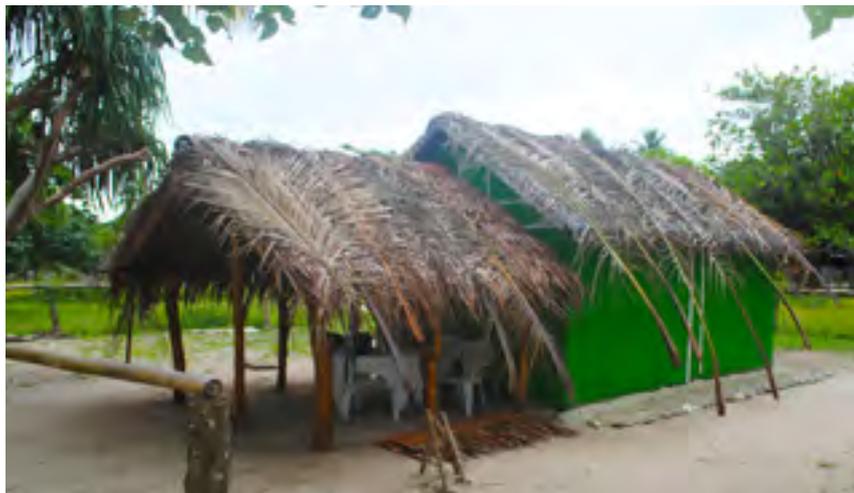
*Before Cyclone Pam*

- Walls and roof of bungalow need repair.
- Toilet roof had to be replaced.
- Rain water contaminated.
- Surrounding bush and gardens destroyed. No shade.

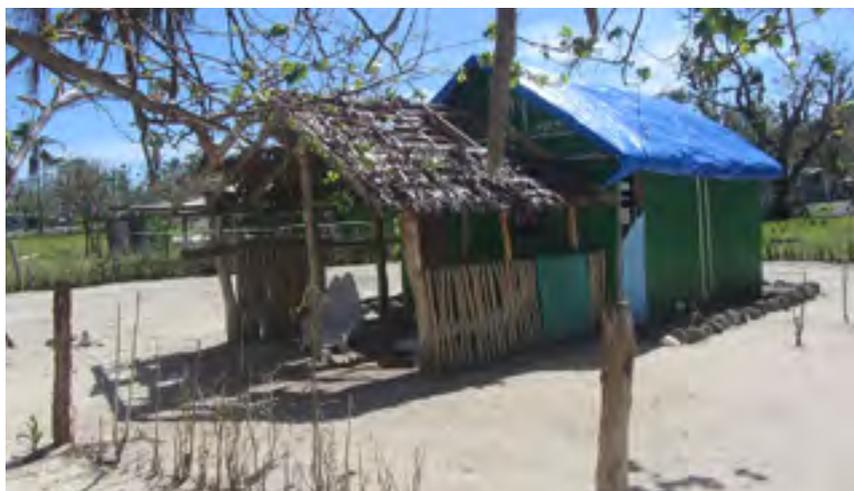
*25 March 2015*

Name: Sunset frangipani Bungalow  
Village: Worearu Village  
Owner: Enock Takaua  
Contact: 534 8534  
Assessed by: Ian Bani / Joseph Obed  
Date: 25/03/2015  
Damage: Significant  
Operational: No

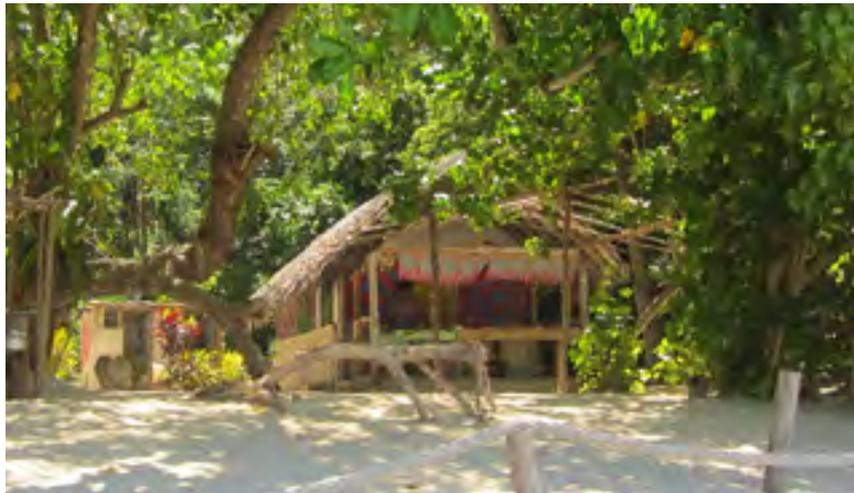
*Before Cyclone Pam*

- Roof needs repairs and veranda rebuilt..
- Rain water contaminated, water supply damaged.
- Surrounding bush and gardens destroyed. No shade.
- Expects to be operational by June 2015.

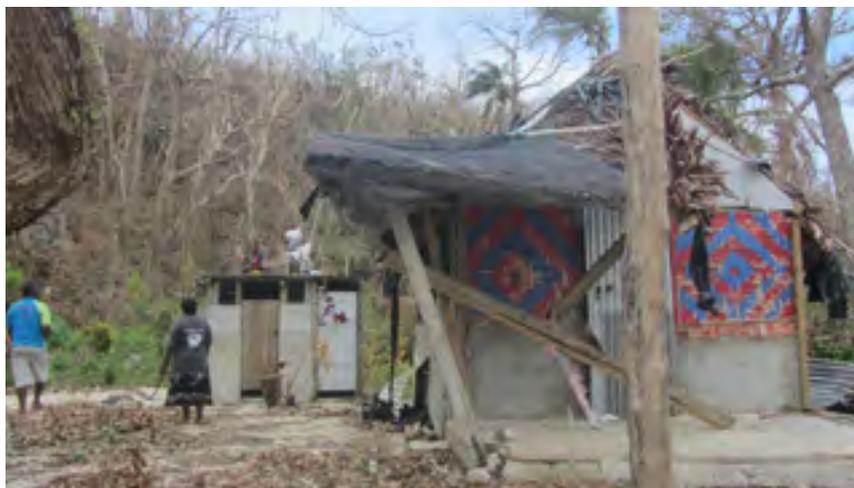
*25 March 2015*

Name: Serety Bungalow  
Village: Pillura Village  
Owner: Charley Sepora  
Contact: 563 0979  
Assessed by: Joseph Obed / Dianne Hambrook  
Date: 25/03/2015  
Damage: Significant  
Operational: No

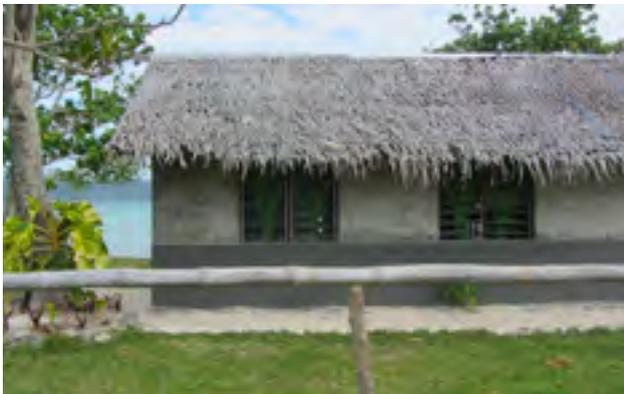
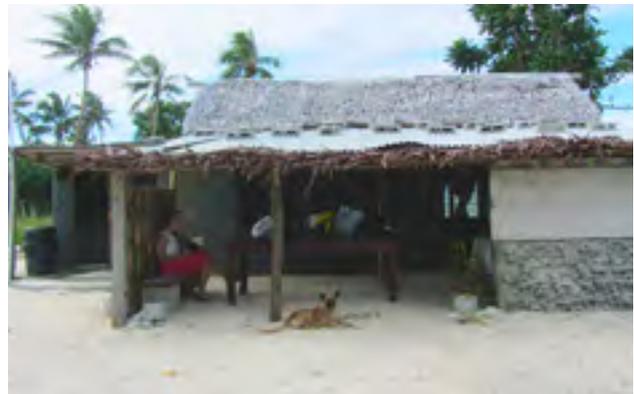
*Before Cyclone Pam*

- Roof and bedrooms need repairing.
- Veranda / dining area and bathroom damaged.
- Beach washed away.

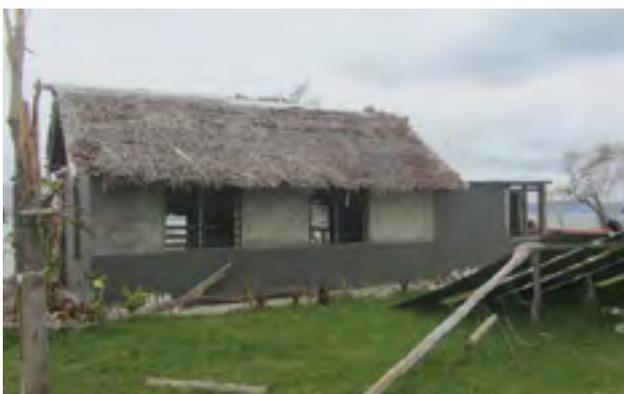
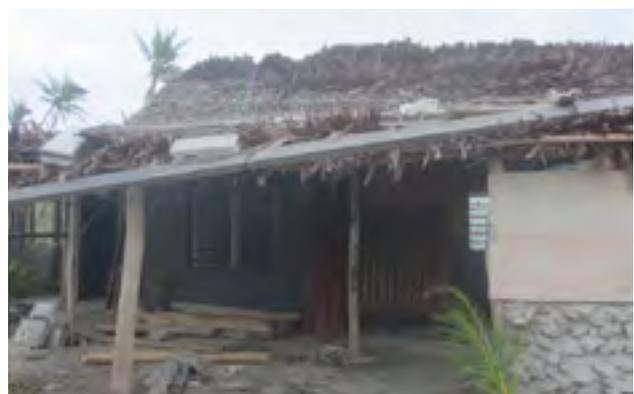
*24 March 2015*

Name: Bela Bungalow  
Village: Worasiviu Village  
Owner: George Kalsong  
Contact: 7762140 / 5915898 or 562 6956 (David Kalsong - son)  
Assessed by: Dianne Hambrook / Kathy Garoleo  
Date: 25/03/2015  
Damage: Significant  
Operational: No

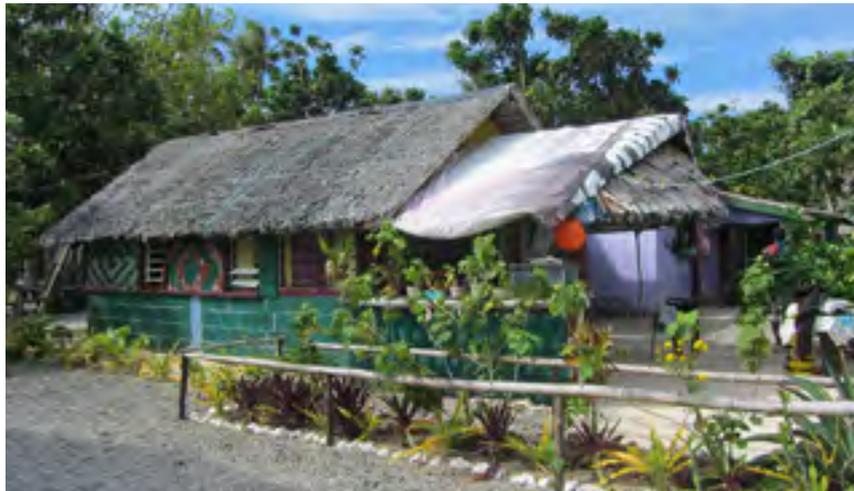
*Before Cyclone Pam*

- Had already made extensive repairs.
- Water supply not operational and regulator for solar lighting damaged.
- Expected to be operational by beginning of May.

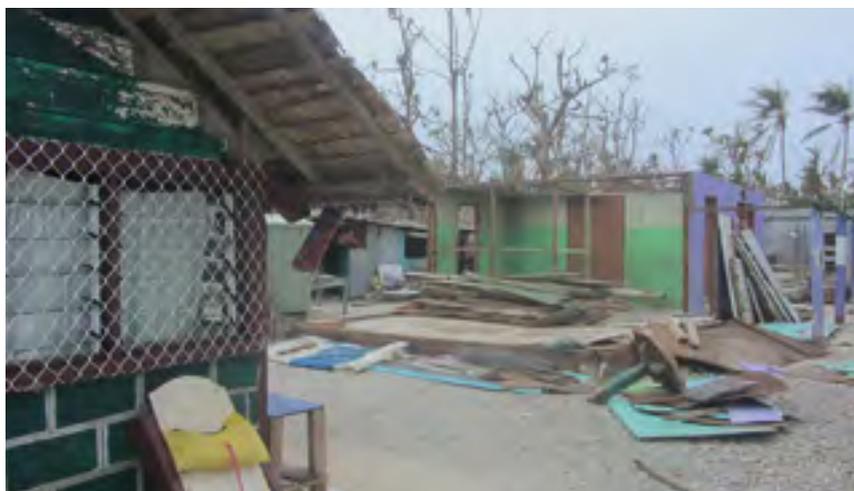
*25 March 2015*

Name: Nabanga Bungalow  
Village: Worasiviu Village  
Owner: Kenneth Talang  
Contact: 563 0315  
Assessed by: Joseph Obed / Dianne Hambrook  
Date: 25/03/2015  
Damage: Moderate  
Operational: No

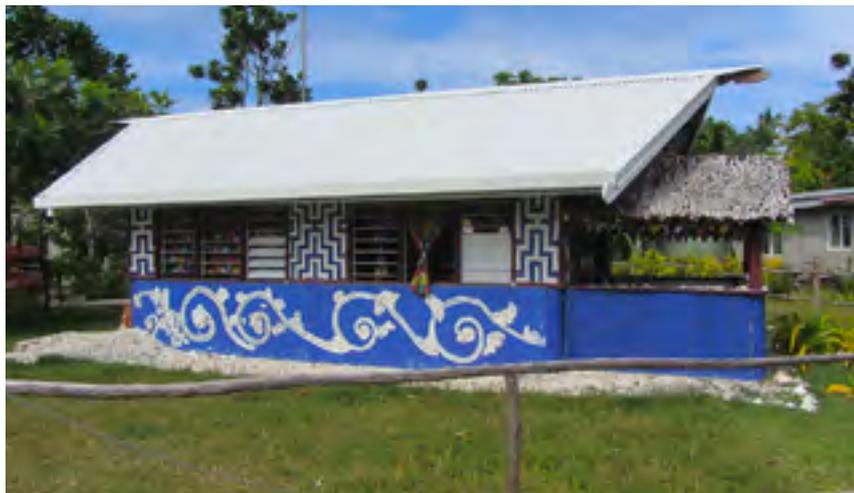
*Before Cyclone Pam*

- Veranda area blown away, roof damaged.
- Water source contaminated and solar batteries destroyed.

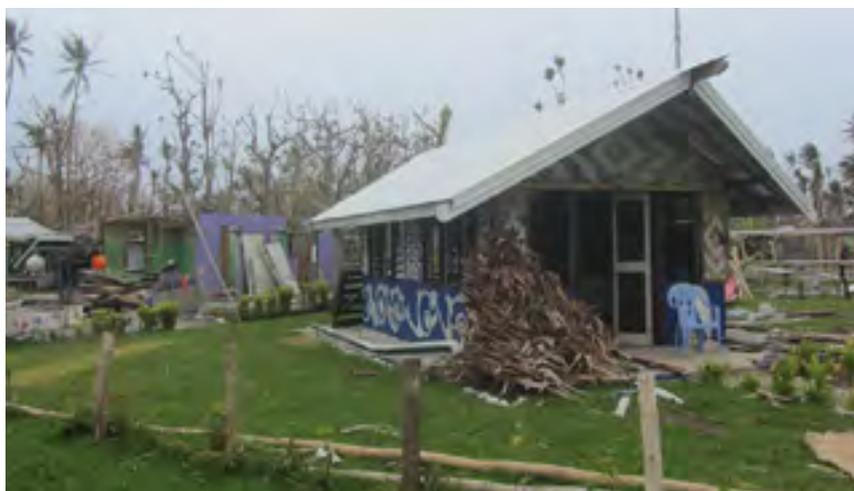
*25 March 2015*

Name: Seahorse Bungalow  
Village: Worasiviu Village  
Owners: Worasiviu Community  
Contact: 568 4229 / 773 6818  
Assessed by: Ian Bani / Kathy Garleo  
Date: 25/03/2015  
Damage: Significant  
Operational: No

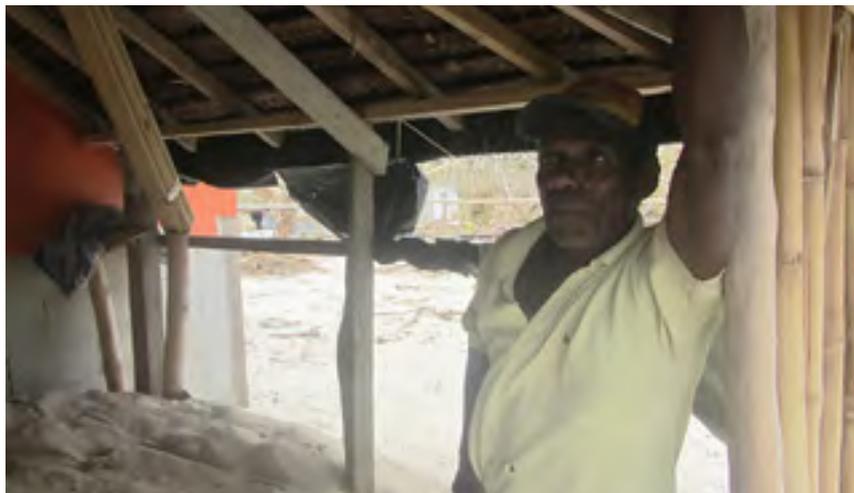
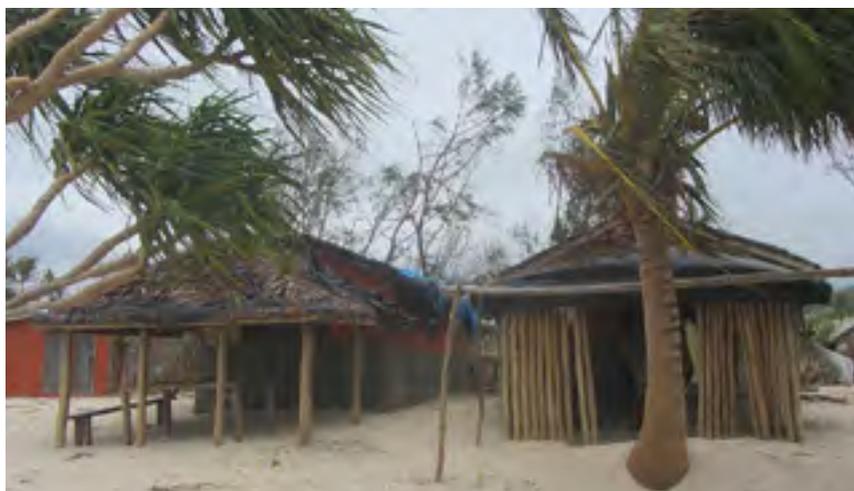
*25 March 2015*

Name: Sunrise Bungalows  
Village: Launamoa Village  
Owner: Tarisu Seth  
Contact: 593 6250  
Assessed by: Kathy Garoleo / Dianne Hambrook  
Date: 25/03/2015  
Damage: Significant  
Operational: No

- Waves and sea surge came inside the bungalows, filling them with sand.
- Water supply contaminated.
- Expects one of the two bungalows (the family bungalow) to be operational by June.
- No exterior pre-cyclone image available.

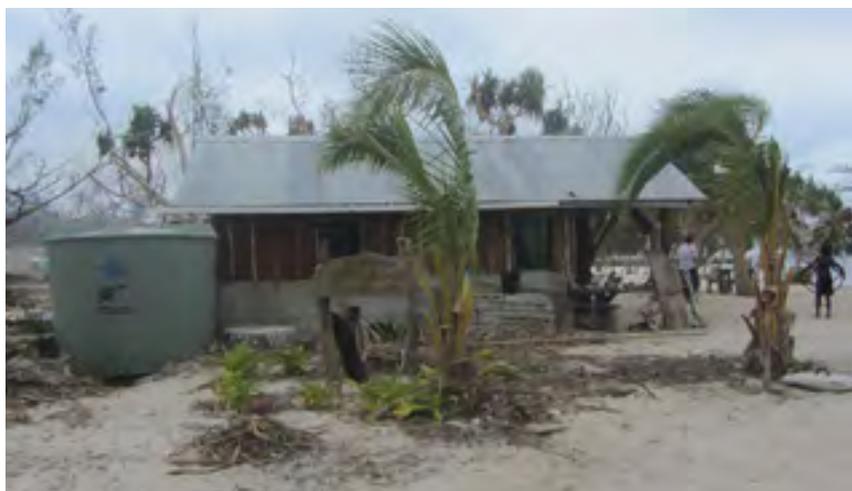
*25 March 2015*

Name: Wora-Namoa Bungalow  
Village: Launamoa Village  
Owners: Launamoa Community (represented by Bill Seth)  
Contact: 591 3890 / 538 9751  
Assessed by: Dianne Hambrook / Kathy Garoleo  
Date: 25/03/2015  
Damage: Moderate  
Operational: No

- Had volunteer tourists staying in the bungalow at time of visit.
- Water supply contaminated.
- Expected to be operational within a month.

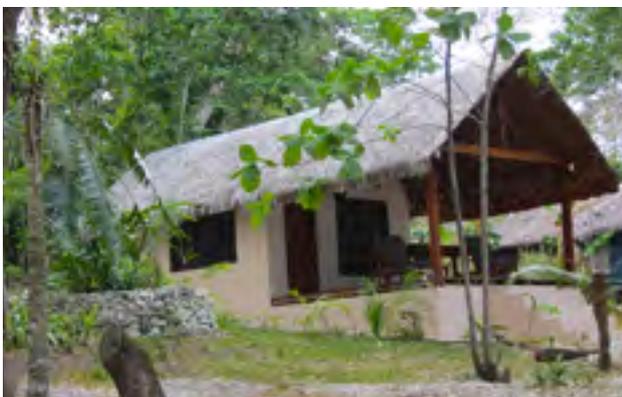
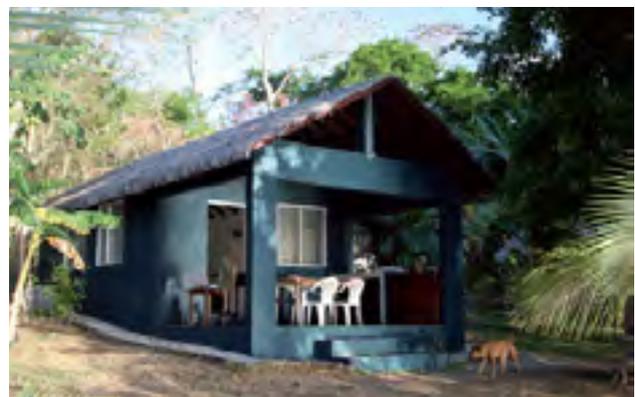
#### *Before Cyclone Pam*

- Roofs need repairing, water damage to all rooms.
- Dining / restaurant area damaged.
- Damage to beach and foreshore.
- Ablution block undamaged and functional.
- Intends to get restaurant operational first and open to day visitors, before repairing bungalows.

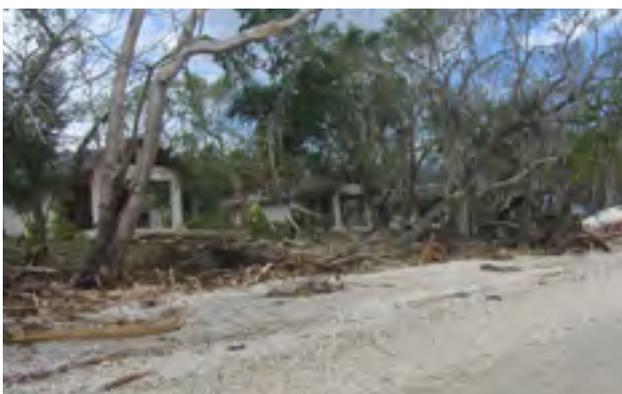
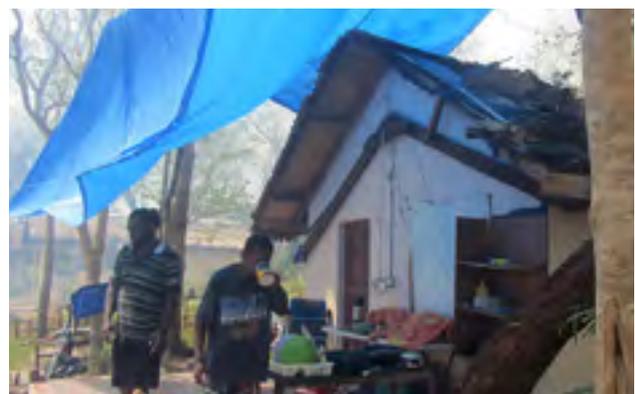
#### *23 March 2015*

Name: Havannah Eco Lodge  
Village: Gideon's Landing, Havannah Harbour  
Owner: Gideon George  
Contact: 774 7200  
Assessed by: Dianne Hambrook / Joseph Obed  
Date: 23/03/2015  
Damage: Significant  
Operational: No

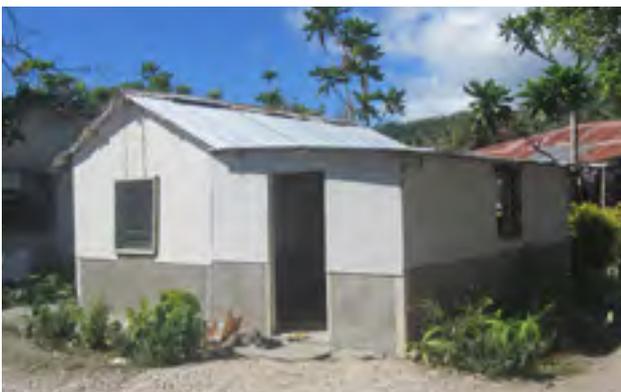
*23 March 2015*

- Roof blew off which has been replaced with corrugated iron because it's difficult to source natangora since the cyclone.
- Woven bamboo on exterior walls were damaged and haven't been replaced because of lack of raw materials.
- Shower and toilet were under construction before the cyclone and are still incomplete.

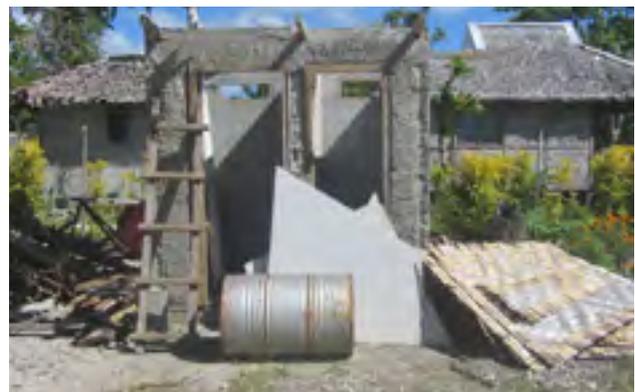
Name: Nikis Bungalow  
Village: Emua Village  
Owners: Ben and Pheppie Frank  
Contact: 594 3772  
Assessed by: Kathy Garoleo / Dianne Hambrook  
Date: 1/06/2015  
Damage: Moderate  
Operational: No

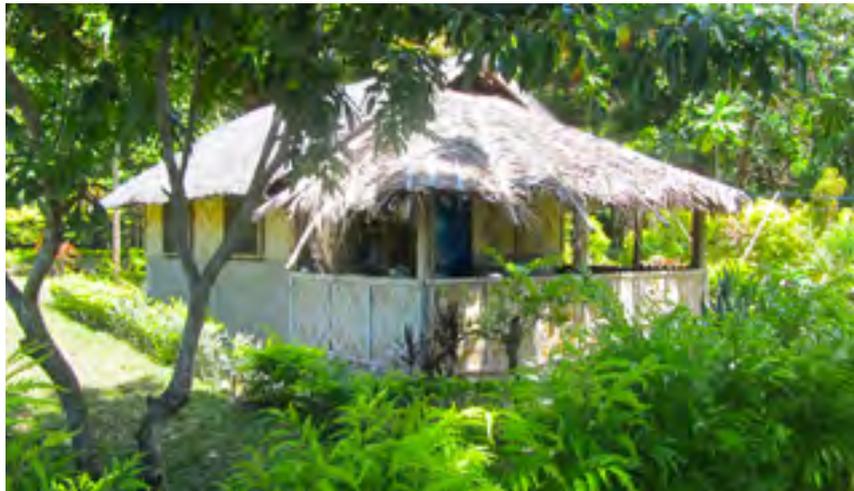
*Before Cyclone Pam*

- The roof was damaged and needs natangora for repairs.
- Owner intends to renovate bungalow.
- Water, power and ablutions are all operational.

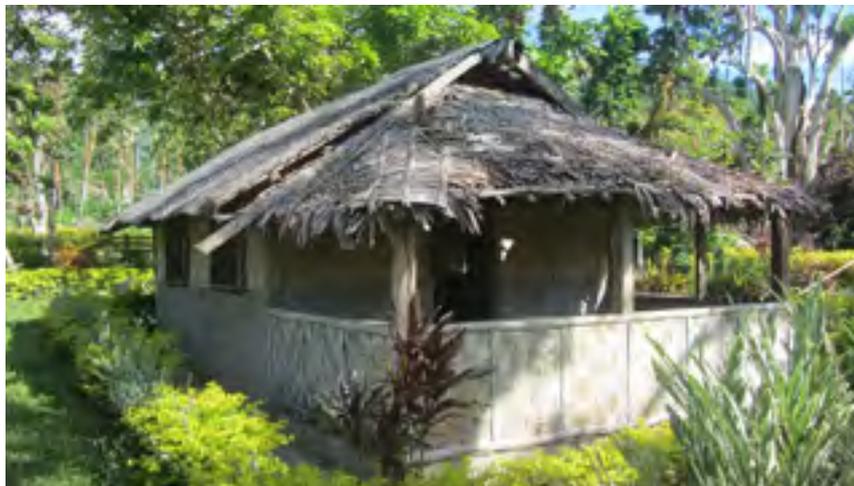
*23 March 2015*

Name: Orovi Bungalow  
Village: Emua Village  
Owners: Kalmet Tasrei  
Contact: 546 2983  
Assessed by: Kathy Garoleo / Dianne Hambrook  
Date: 15/05/2015  
Damage: Minor  
Operational: No

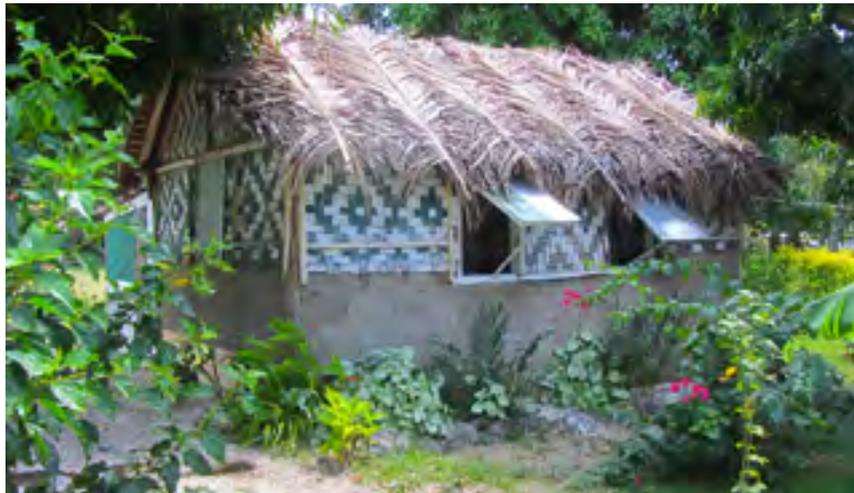
*Before Cyclone Pam*

- Roof damaged and needs repairs to make it waterproof.
- Exterior bamboo damaged.
- Toilet and shower don't have water and need extensive repairs.

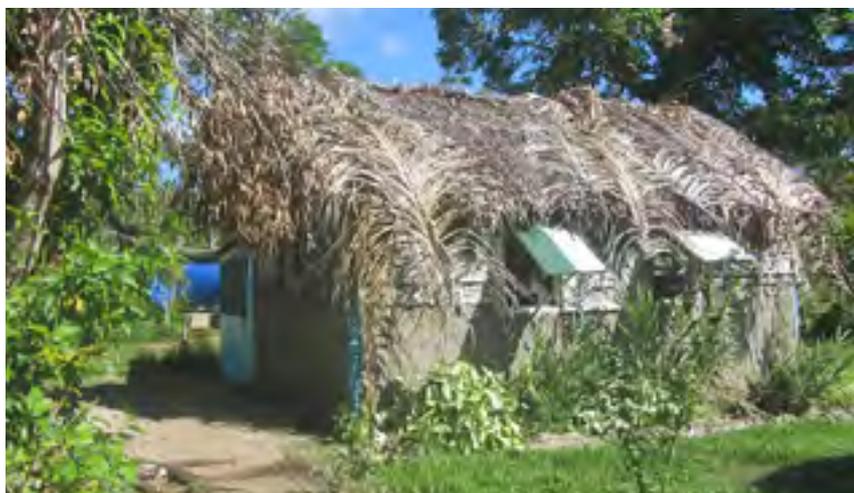
*23 March 2015*

Name: Sunset Bungalow  
Village: Emua Village  
Owner: Annemarie Obed  
Contact: 535 7259 (through daughter, Marion)  
Assessed by: Kathy Garoleo / Dianne Hambrook  
Date: 1/06/2015  
Damage: Moderate  
Operational: No
