# POST-CYCLONE RECOVERY PLAN FOR NI-VANUATU TOURISM BUSINESSES IN SHEFA PROVINCE

## STAGE 1 - EFATE, NGUNA & PELE ISLANDS

JUNE 2015

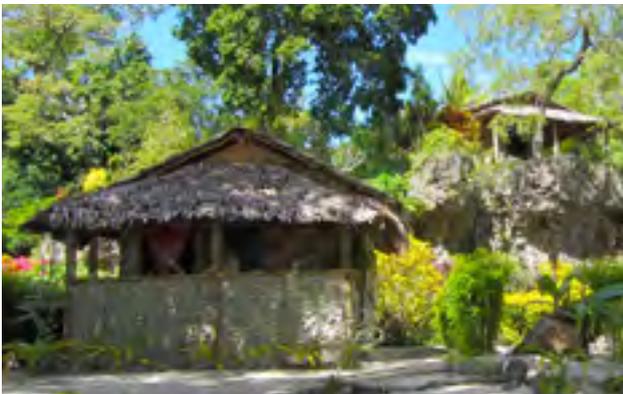
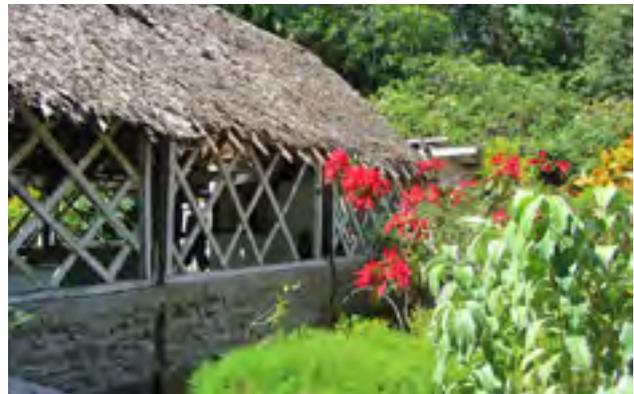
#### *Before Cyclone Pam*

- The bungalow on the top level was extensively damaged and needs an new roof.
- The roof of the older of the two bungalows on the lower level needs repairs.
- Shower and toilet in good condition but there is no water supply.
- No power.
- Grounds and beach have been cleaned up after the cyclone and are looking good.
- Old restaurant has been completely removed.

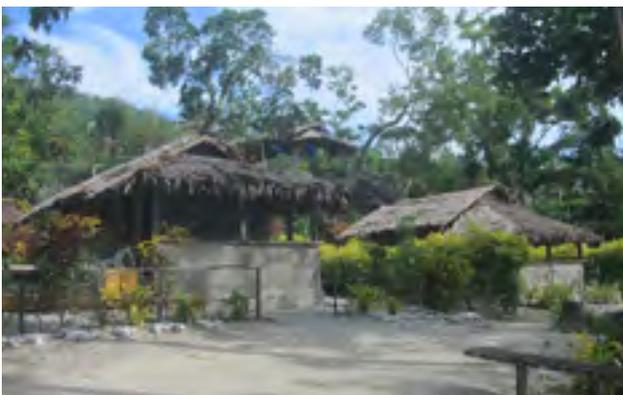
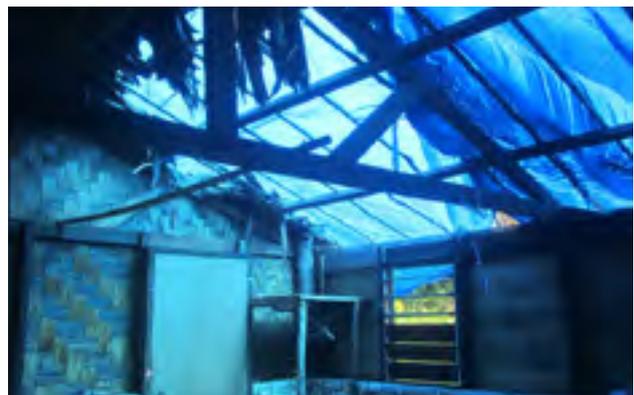
#### *23 March 2015*

Name: Vatupau Bungalows  
Village: Emua Village  
Owners: Kenneth Lango  
Contact: 546 2052 | 546 5019  
Assessed by: Kathy Garoleo / Dianne Hambrook  
Date: 15/05/2015  
Damage: Moderate  
Operational: Yes (1 of 3 bungalows)

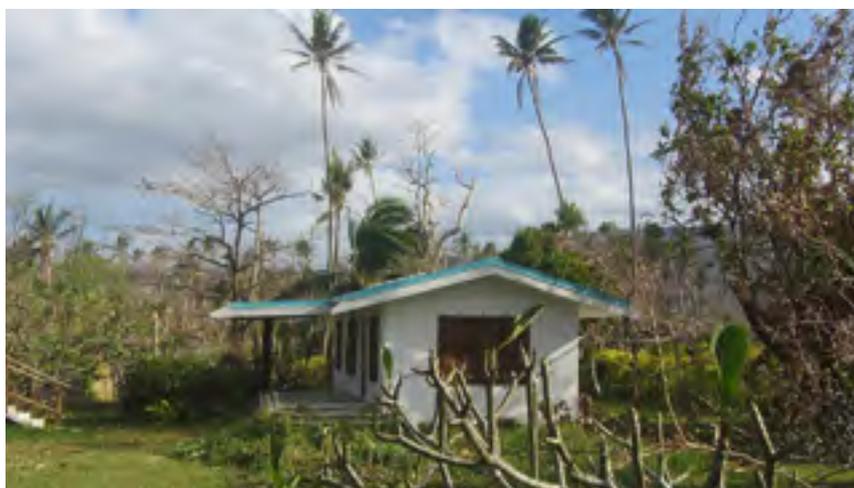
*23 March 2015*

Name: Malowia Guesthouse  
Village: Paunangisu Village  
Owners: Willie and Janet Bunyan  
Contact: 777 4091  
Assessed by: Joseph Obed / Dianne Hambrook  
Date: 23/03/2015  
Damage: None  
Operational: Yes

- Gardens and chicken coop damaged.
- Lack of fresh food for meals.
- Operational and receiving guests.
